**Re: Request for Modification to 12-18-2013 Risk Based Disposal Approval
Supplement to Rainier Commons Phase I Close-Out Report**

Subject: Polychlorinated Biphenyl (PCB) Substrate Testing
CONCRETE - POST VISUAL CLEARANCE

Site Address: Rainier Commons, LLC
3100 Airport Way S, Seattle, WA

NVL Project#: 2012-494

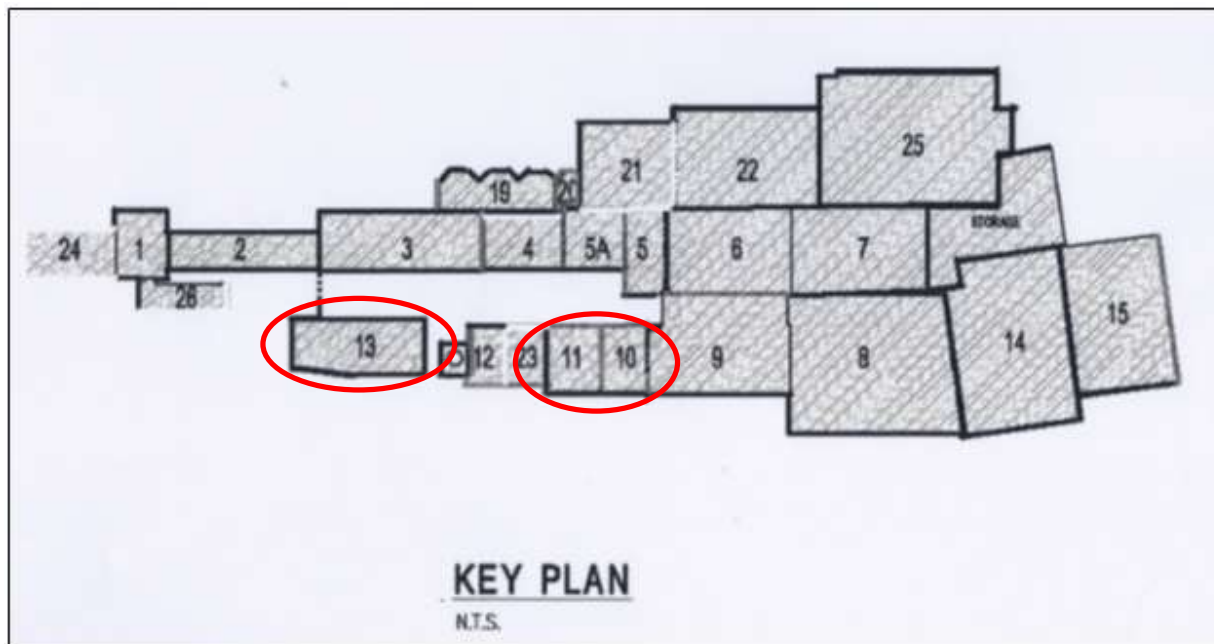
SITE MAP

The circled area on this site map shows the locations of buildings 10, 11 and 13 at Rainier Commons.

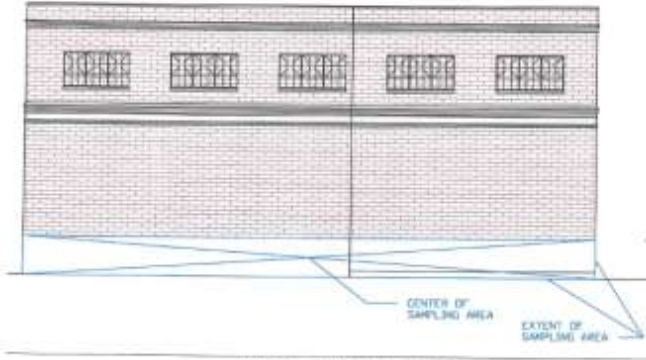
1	<p>DETERMINING SAMPLING GRID LOCATION, TYPICAL</p>

<p>CENTER OF SAMPLING AREA EXTENT OF SAMPLING AREA</p> <p>WEST ELEVATION BUILDING 13</p>	<p>Determining sampling grid location – typical – West Elevation Building 13</p>
2	<p>ESTABLISHING GRID PATTERN</p>

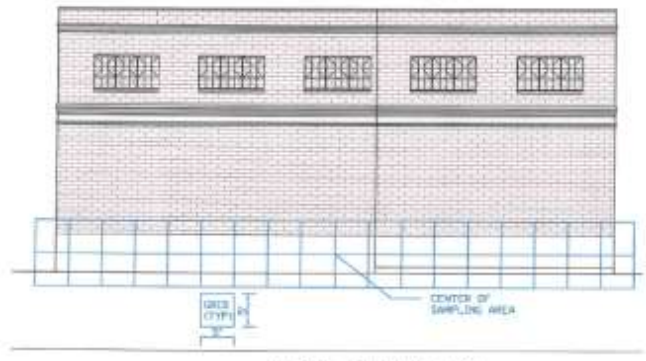
<p>CENTER OF SAMPLING AREA</p> <p>WEST ELEVATION BUILDING 13</p>	<p>Establishing grid pattern – West Elevation Building 13</p>

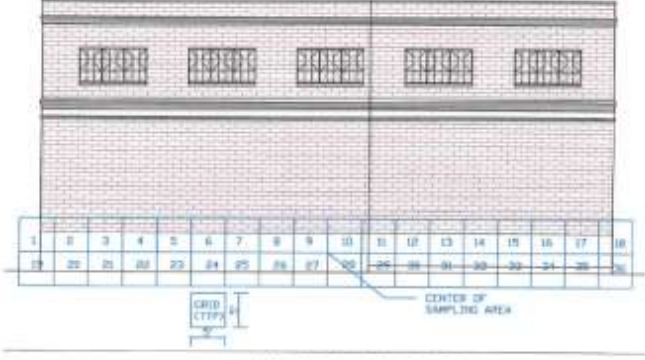
3	<p style="text-align: center;">ASSIGNING GRID IDENTIFICATION</p>

<p style="text-align: center;">WEST ELEVATION BUILDING 13</p>	<p>Assigning Grid Identification – West Elevation Building 13</p> <p>Grid locations #1 to #36</p>
4	<p style="text-align: center;">ASSIGNING GRID IDENTIFICATION</p>

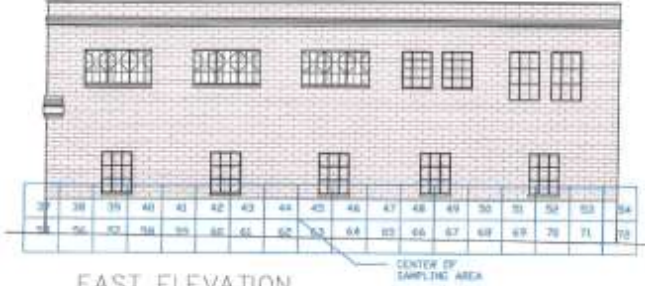
<p style="text-align: center;">EAST ELEVATION BUILDING 13</p>	<p>Assigning Grid Identification – East Elevation Building 13</p> <p>Grid locations #37 to #72</p>
5	<p style="text-align: center;">ASSIGNING GRID IDENTIFICATION</p>

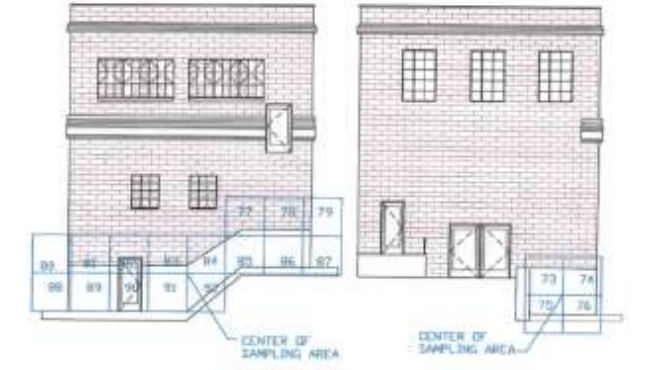
<p style="text-align: center;">SOUTH ELEVATION NORTH ELEVATION BUILDING 13 BUILDING 13</p>	<p>Assigning Grid Identification – South & North Elevation Building 13</p> <p>Grid locations #73 to #92</p>

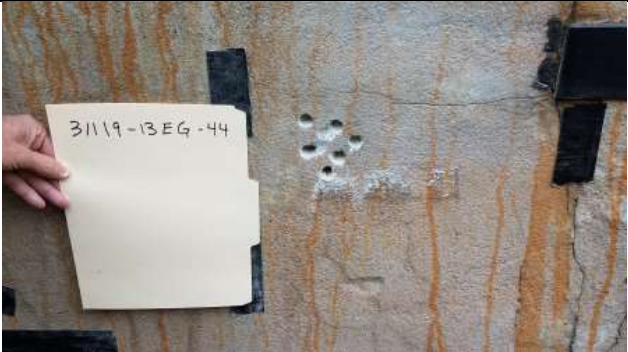
1

<p>Location 44-3-4</p> <p>Samples collected at this location: 31119-13EG-44 31119-13EG-44-DUP 31119-13EG-44-SPLIT</p> <p>Streaking on the concrete surface was caused by the application of a moss killer in 2018</p> <p>Surface debris was removed using a clean brush and cloth prior to drilling.</p> <p>The six holes at this location are the result of first drilling four holes to create ~20 grams of material to create split QA/QC samples. The second two holes were for collection of ~10 grams of material for the duplicate QA/QC sample.</p>
---	---	---

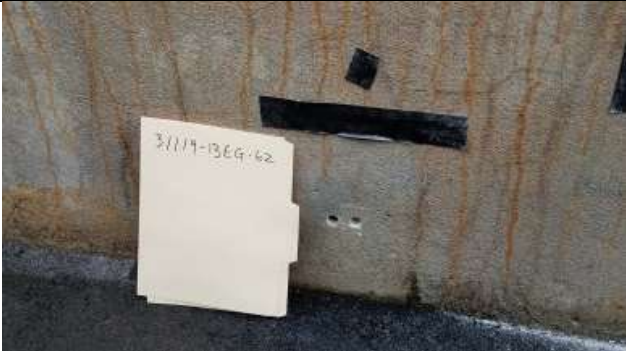
2

<p>Location 62-1-3</p> <p>Sample collected at this location: 31119-13EG-62</p> <p>Two holes were drilled at this location to obtain ~10 grams of material for the single sample.</p>
3

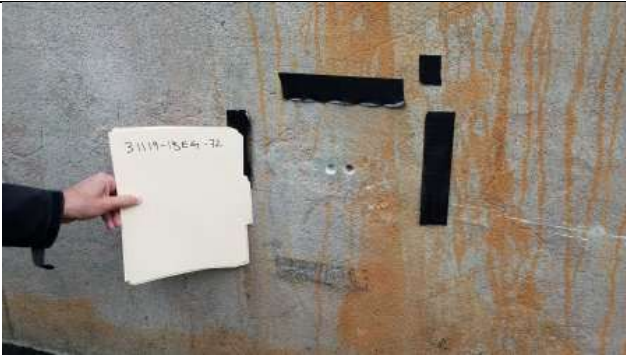
<p>Location 72-1-1</p> <p>Sample collected at this location: 31119-13EG-72</p> <p>Two holes were drilled at this location to obtain ~10 grams of material for the single sample.</p>
4

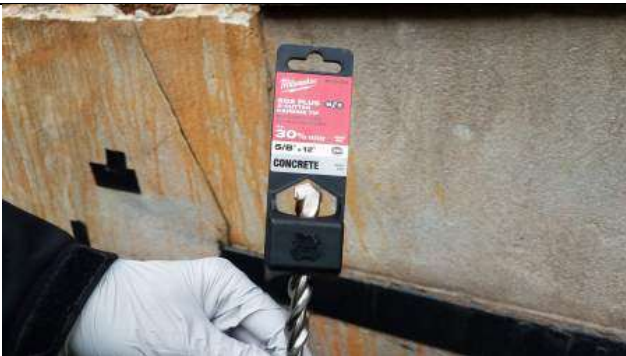
<p>Concrete Drill Bit</p> <p>Samples were collected using an impact hammer drill with a 5/8 inch concrete drill bit to generate a uniform, finely ground powder. Depth was controlled to be no more than one half inch by marking the depth with tape on the drill bit.</p>

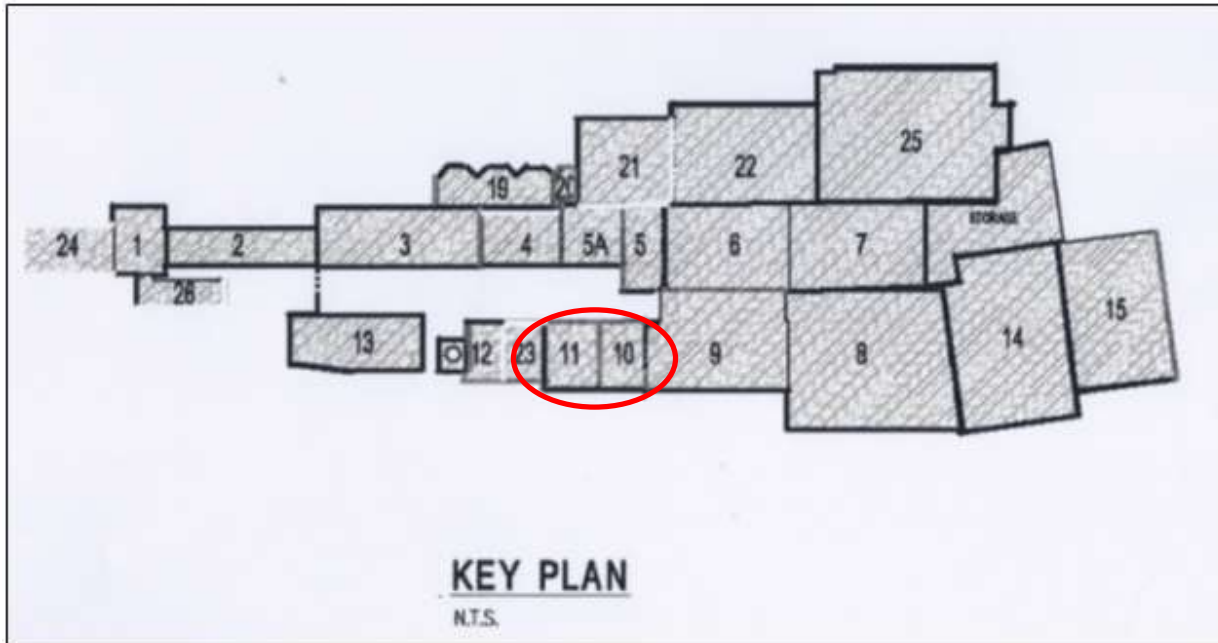
SITE MAP

The circled area on this site map shows the locations of buildings 10 and 11 at Rainier Commons.

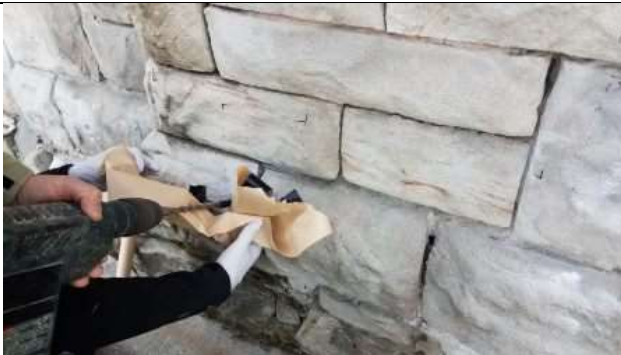
2

Location 26-1-2 As with all locations, samples were collected using an impact hammer drill with a 5/8 inch concrete drill bit to generate a uniform, finely ground powder. Depth was controlled to be no more than one half inch by marking the depth with tape on the drill bit.
3

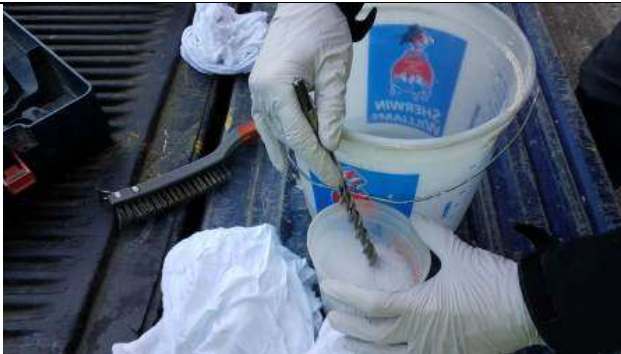
Cleaning Drill Bit Step 1- Soap wash The drill bit was cleaned and decontaminated before use, and after each sample was obtained per the description in the sampling plan, which included scrubbing with water containing detergent, followed by rinsing with clean water, then rinsing/wiping the surface with hexane.
4

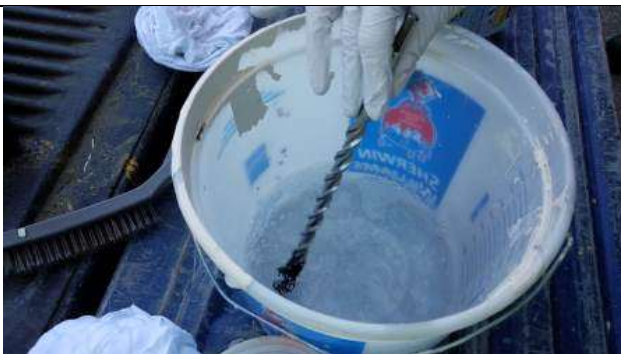
Cleaning Drill Bit Step 2 - Rinse The washed drilled bit is being rinsed in a bucket with clean water.
5

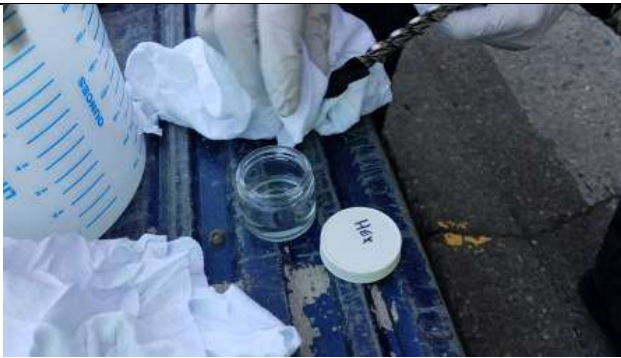
Cleaning Drill Bit Step 3 – Hexane The surface of the rinsed drill bit is being wiped with a clean cloth that was wetted with hexane.

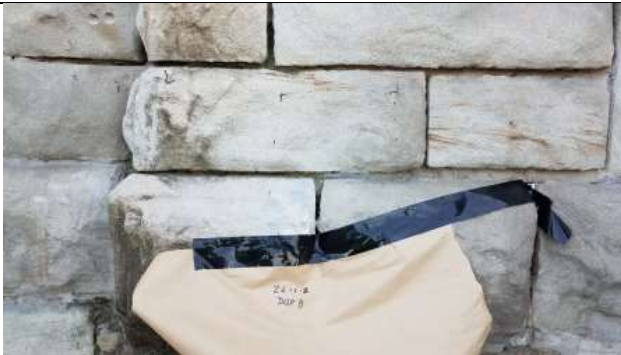
6

<p>Location 26-1-2</p> <p>Area prepared to collect the field duplicate sample which was a separate QA/QC sample collected as close as possible to the original sample.</p> <p>Sample collected at this location: 32219-10WG-26-DUPB</p>
7

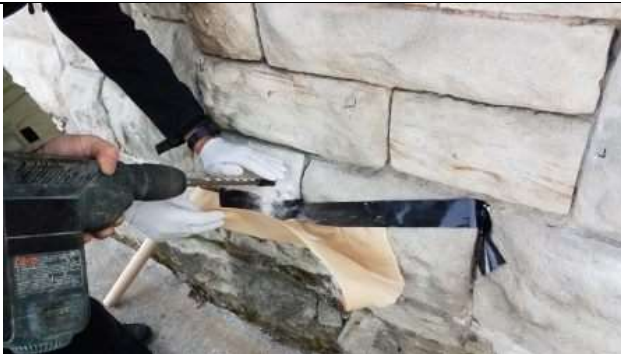
<p>Location 26-1-2</p> <p>To collect the field duplicate sample two holes were drilled adjacent to the previous drill holes to obtain ~10 grams of material for the single sample.</p>
8

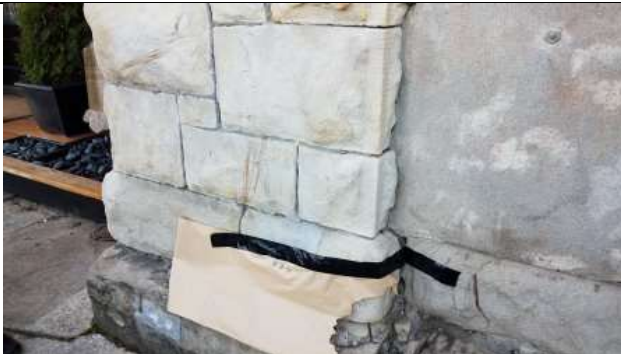
<p>Location 8-3-4</p> <p>Sample collected at this location: 32219-10WG-8</p>
9

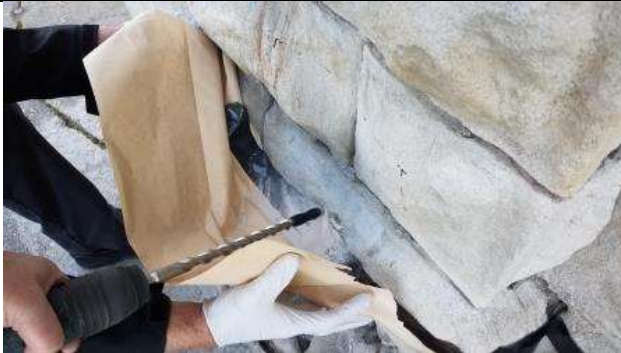
<p>Location 8-3-4</p> <p>Collecting sample 32219-10WG-8 with an impact hammer drill with a 5/8 inch concrete drill bit with the finely ground powder dropping onto to paper below to catch the material.</p>
